# SEATTLE CITY LIGHT WORK ORDER #89-6 1989 QUARTERLY MONITORING OF THE GEORGETOWN FLUME

RAVEN SERVICES CORPORATION 2200 SIXTH AVENUE, SUITE 519 SEATTLE, WASHINGTON 98121 (206) 443-1126; FAX (206) 443-1128

June 21, 1989

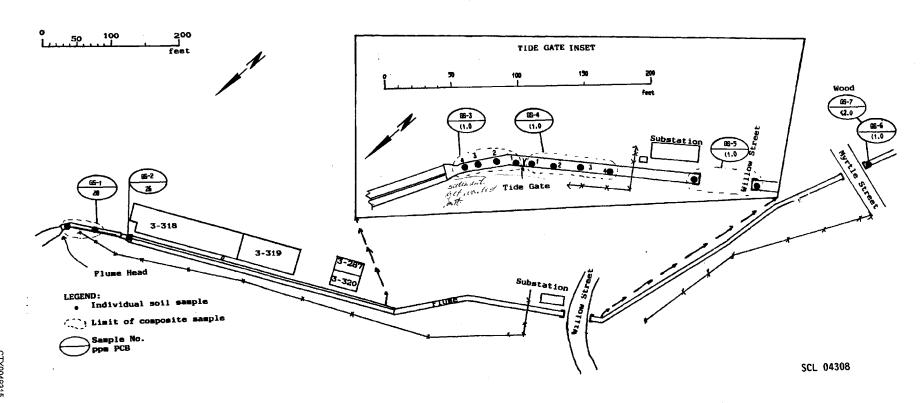
LOCATION OF SAMPLING POSITIONS, GEORGETOWN FLUME

Wood cores were specified for this project, however, since the wire mesh prevented the use of the corer upstream of Myrtle Street, a core was obtained there. Raven has since devised a corer that can sample any of the wood floor locations for future use. Sampling locations are shown in the Figure.

For the next monitoring task, we recommend that sampling at Myrtle Street be dropped, and that two wood cores are obtained between Willow Street and the double pipe mouth. The total number of samples remains at seven. Seattle City Light might consider pumping out the flume head in the near future.
